Public Scoping Meetings September 15 & 16, 2014

Project Corridor/Existing Conditions

“3R” Project – Resurface, Restore, Rehabilitate

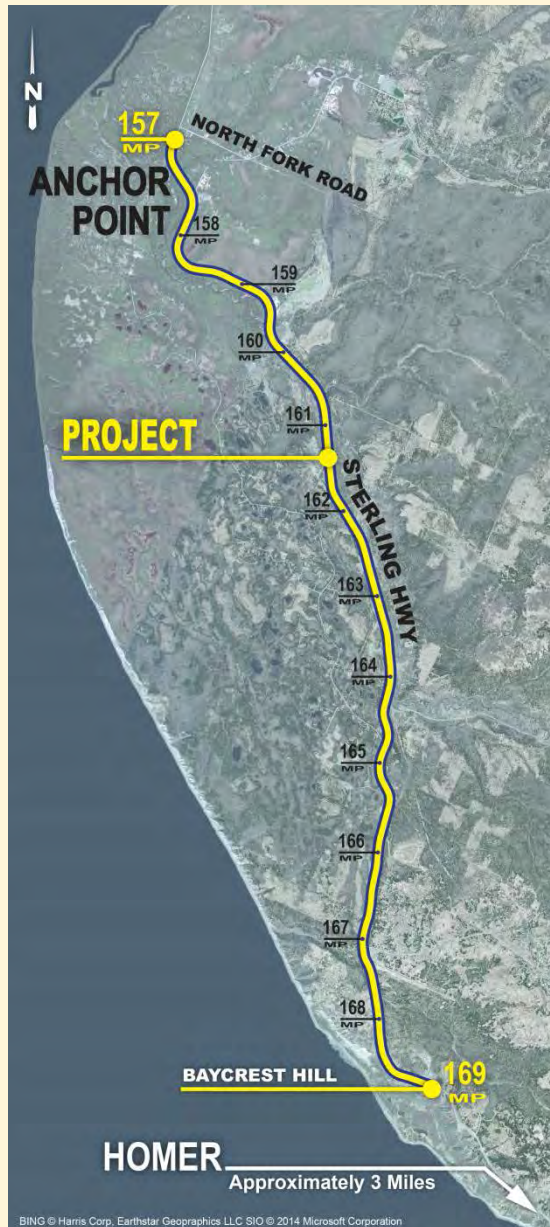
- Built in 1950s, realigned in 1960s
- Existing Roadway
 - 200'+ wide right of way
 - 12-foot lanes
 - 4-foot shoulders
 - 55 mph (45 mph segments near Anchor Point and Homer)
- Average daily traffic volume in 2013 is 4,240
- Sterling Highway is part of the National Highway System
- Only surface access route to Anchor Point and Homer

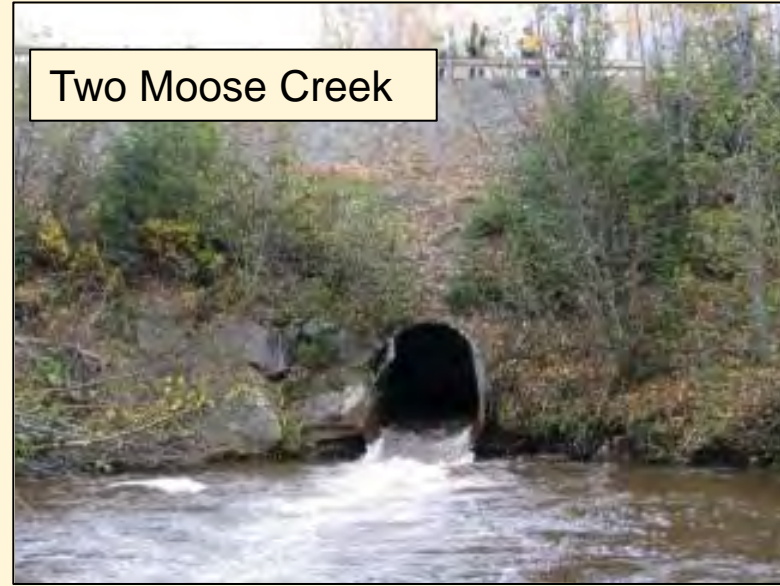
Two Moose Creek

- Culverts
 - More than 60 culverts are in need of repair or are undersized
 - 5 streams don't meet fish passage criteria
 - Debris issues at North Fork Anchor River caused embankment damage in 2002 and 2012 floods

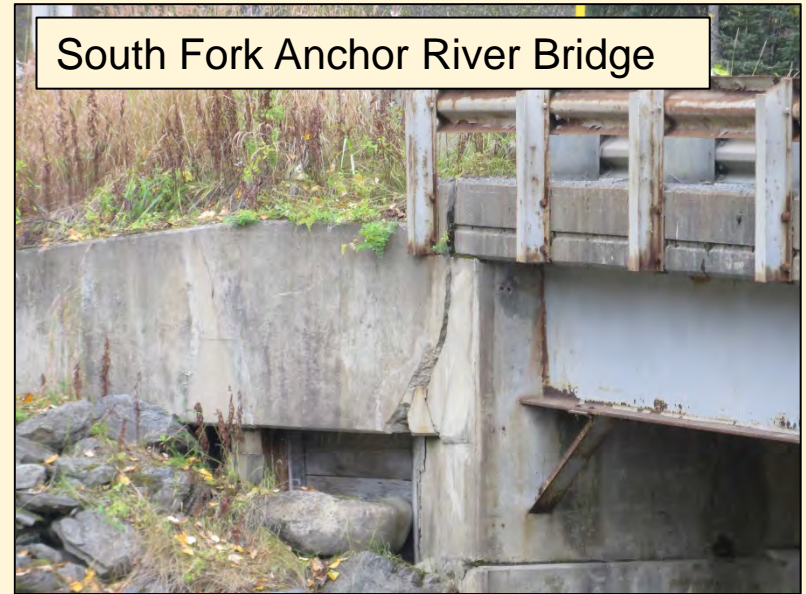
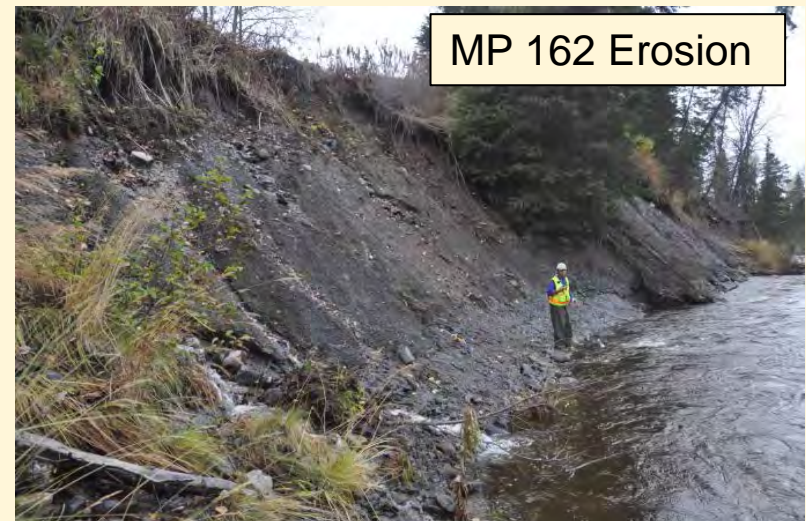
Structures/Drainage (cont'd)

- Bridge Condition
 - South Fork Anchor River
 - Deteriorated abutments
 - Visible cracks
- Erosion
 - Anchor River undermining the bank near the roadway

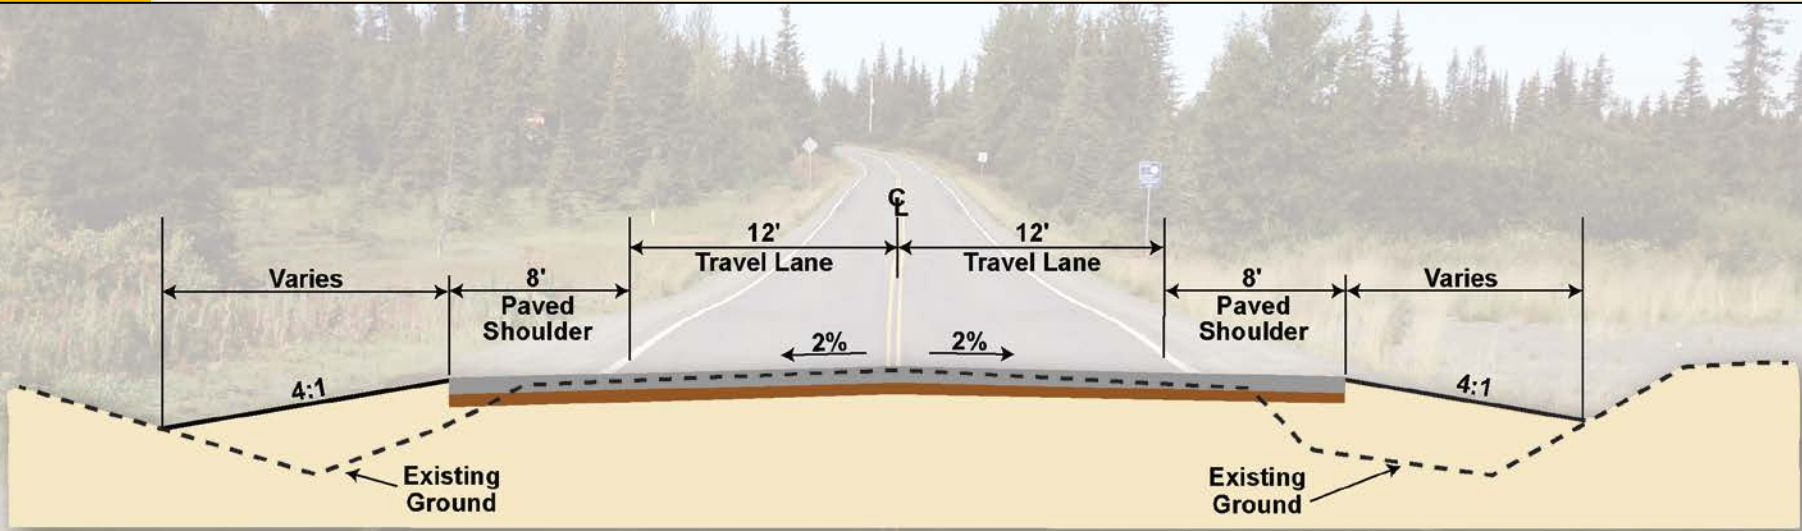
2-Lane Typical Section

- New bridges at North and South Fork Anchor Rivers
- New passing and climbing lanes
- New culverts
- 8’ shoulders throughout
- Clearing
